Missouri River Shallow Water Habitat Accounting Report – 2010

Omaha District Missouri River Shallow Water Habitat Report December 2010

OFFICE REPORT
Shallow Water Habitat Reconnaissance
Missouri River Chutes, Omaha District
AUGUST 2009

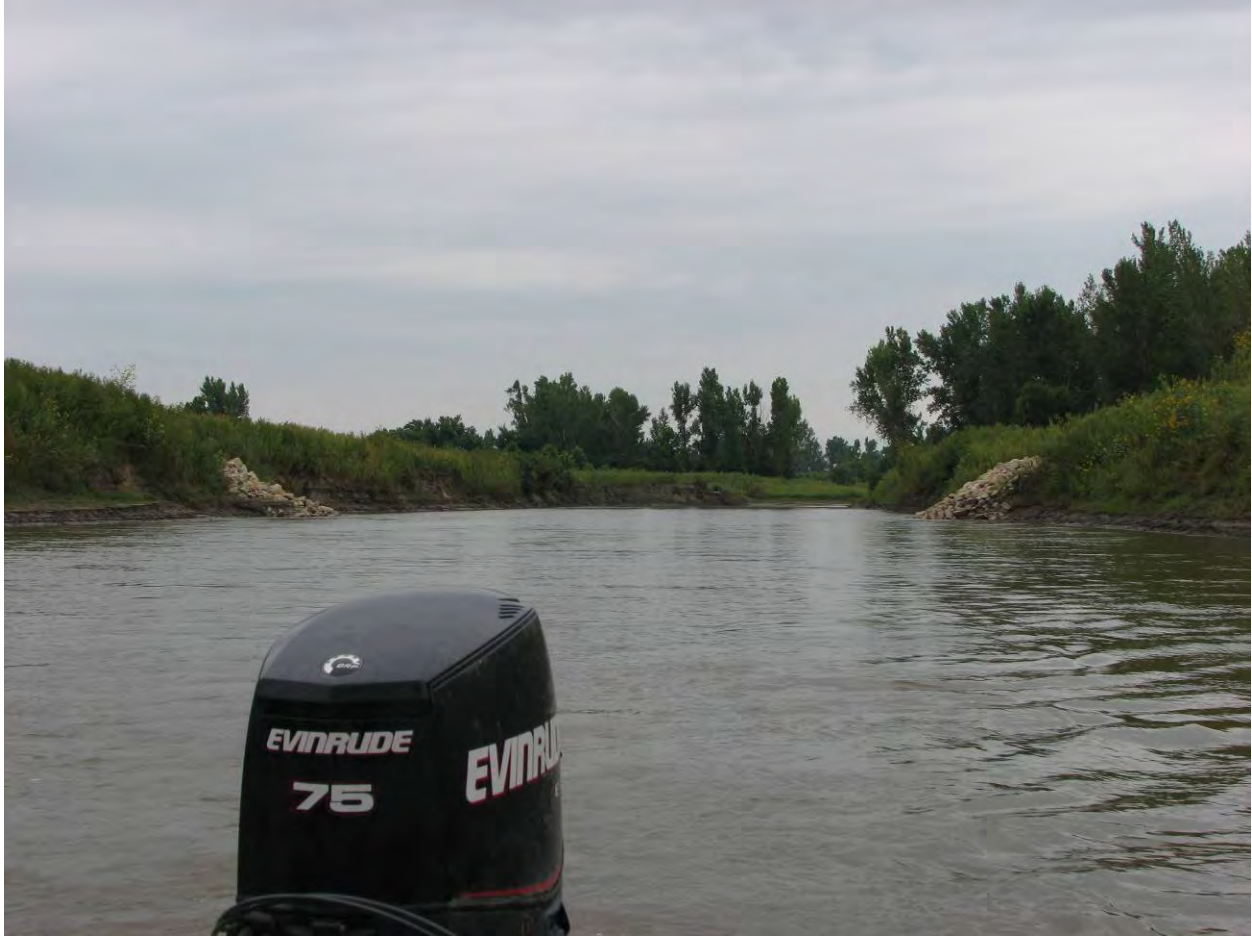
Vertical banks throughout also indicate active erosion. Both grade control structures are in good condition with rock visible on both banks. The banks have eroded back farther than the edges of the structure. The structures do not appear to be in immediate danger of being flanked but monitoring of this

Figure 46 – Grade control structure showing extents of erosion.

situation is recommended. See Figure 46.

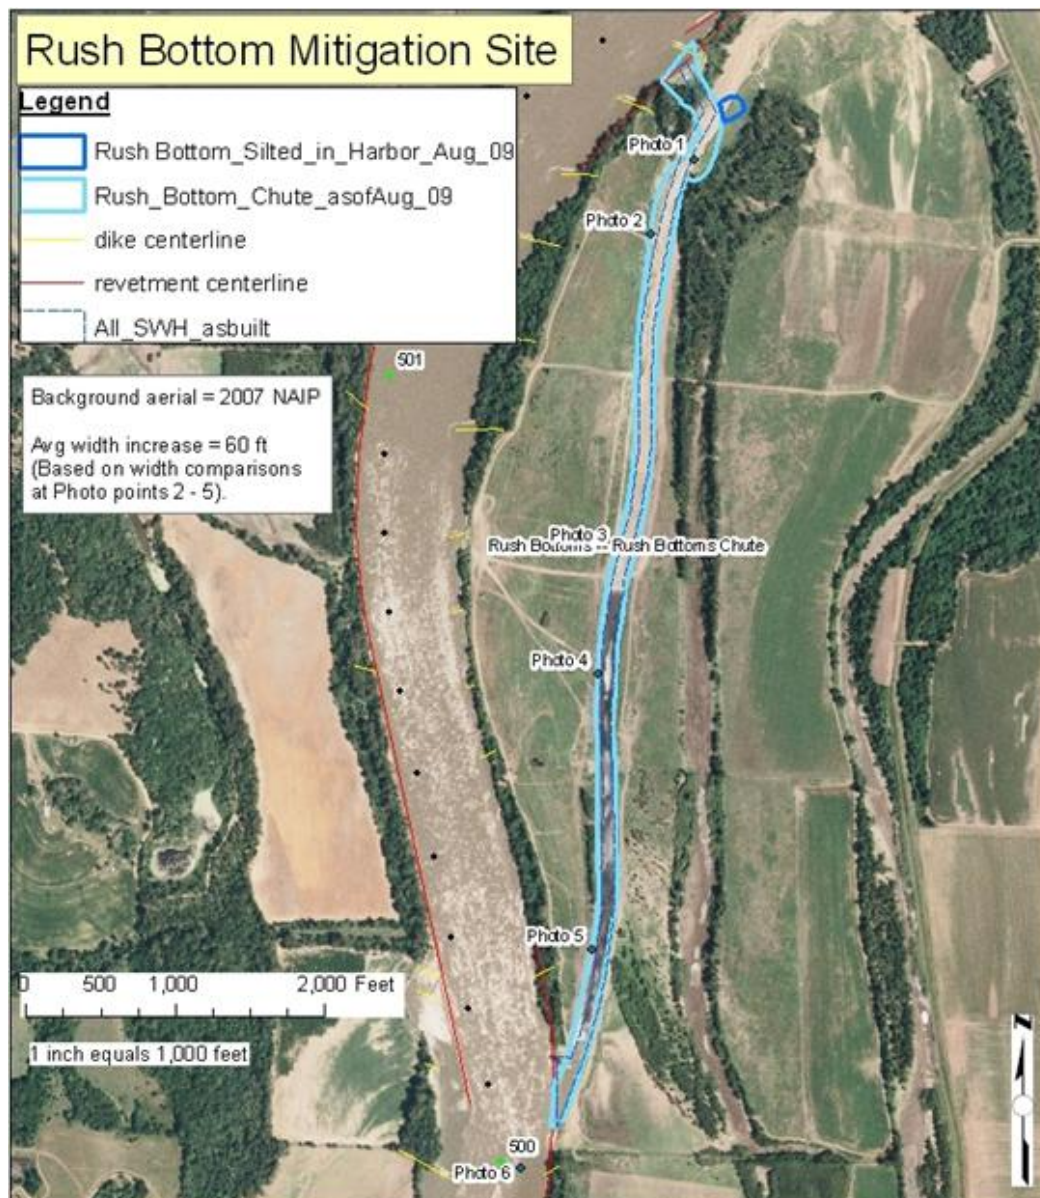
Rush Bottom top width comparison (zoomed out view)

Rush bottom designed width was approximately 70 ft, and in August 2009 inspection average width increased by 60 ft.
